Asset Management Plan

Keeping the energy flowing

TRANSPOWER

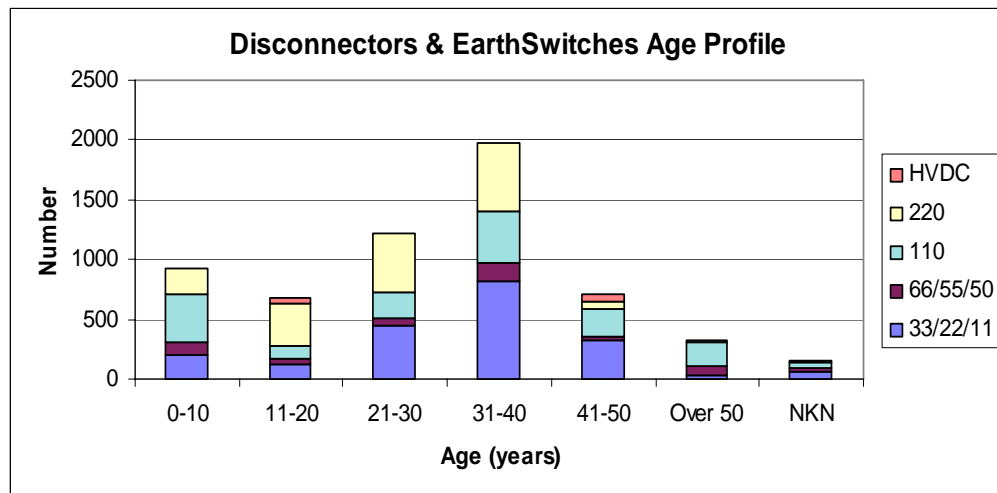
Figure 3-5: Disconnecter and earth switch age profile

The age profile of the disconnector population is shown in [Figure 3-5](#).

Transpower’s disconnector and earth switch population has an average age of 28 years.

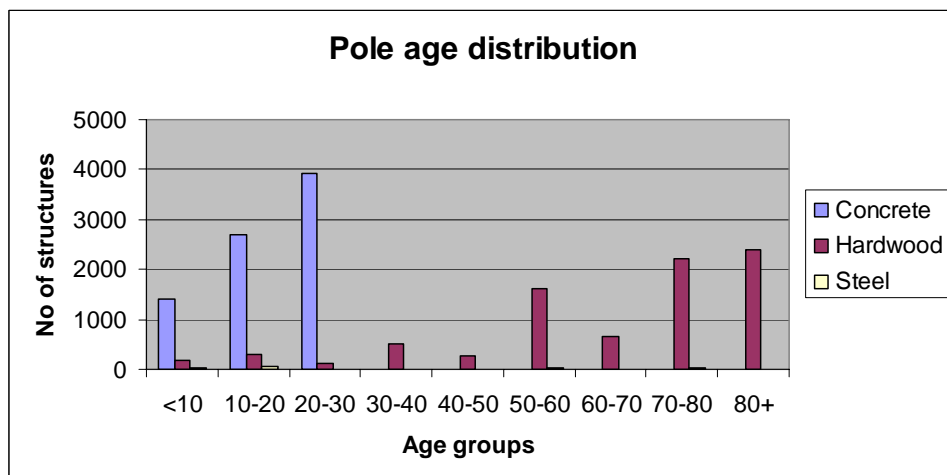
Figure 3-11: Pole age distribution

Transpower began installing concrete poles in preference to hardwood poles in the early 1990s. A total of 8,032 wood pole structures remain in service, most of them original. [Figure 3-11](#) shows the age profile for concrete, hardwood and steel poles.

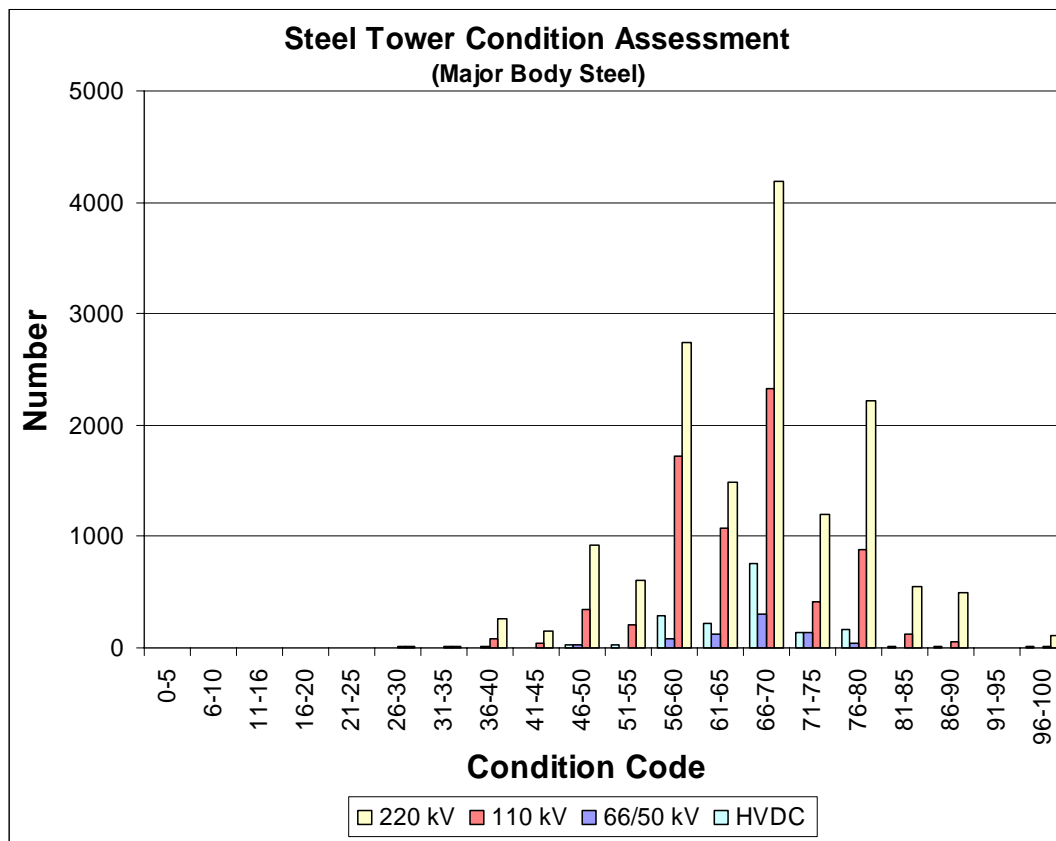
Figure 3-12: Steel tower condition assessment

Transpower began painting towers in the early 1990s, based on assessment of zinc coating losses. To date, about 2350 towers have been painted. [Figure 3-12](#) provides steel tower condition assessment ratings by circuit voltage category.

As can be seen in [Figure 3-12](#), a significant number of the steel towers are approaching the 50 per cent or less condition assessment rating when painting would optimally occur.

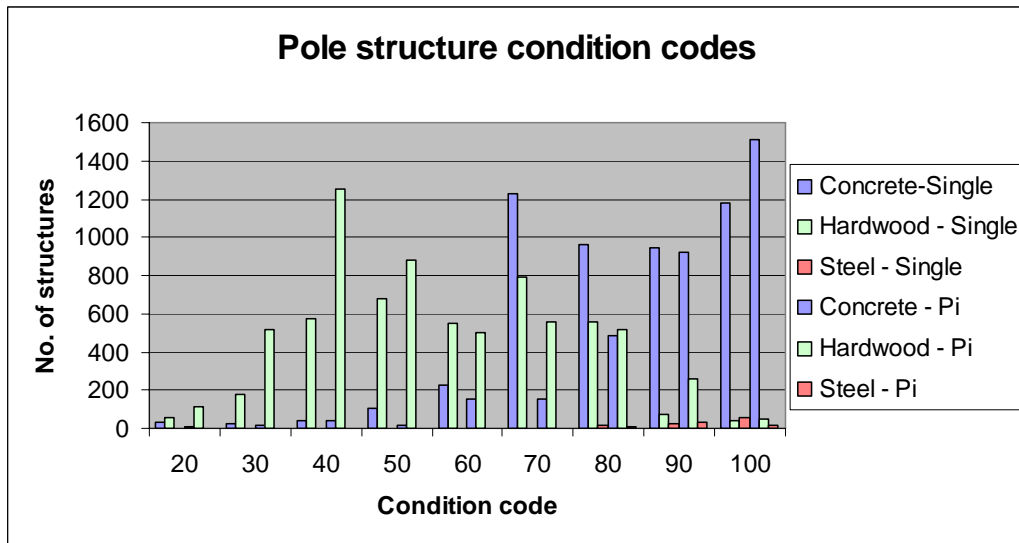
Figure 3-13: Pole structure condition assessment

[Figure 3-13](#) shows the condition codes for concrete, steel and wooden poles. A code of 100 indicates 'as new' condition, while a code of 20 indicates replacement criteria have been met.

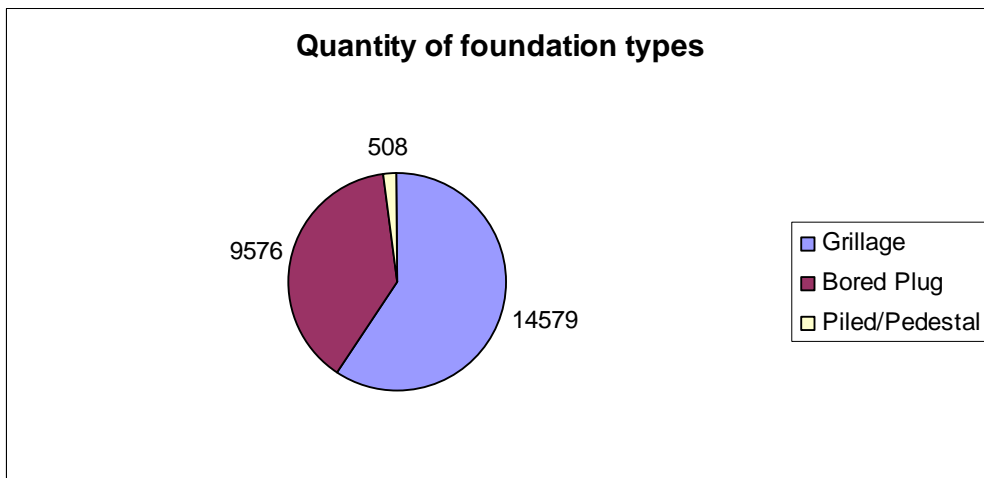
Figure 3-14: Quantity of foundation types

Piled/pedestal foundations are generally used at or near river crossings. [Figure 3-14](#) shows the relative numbers of foundations by type.

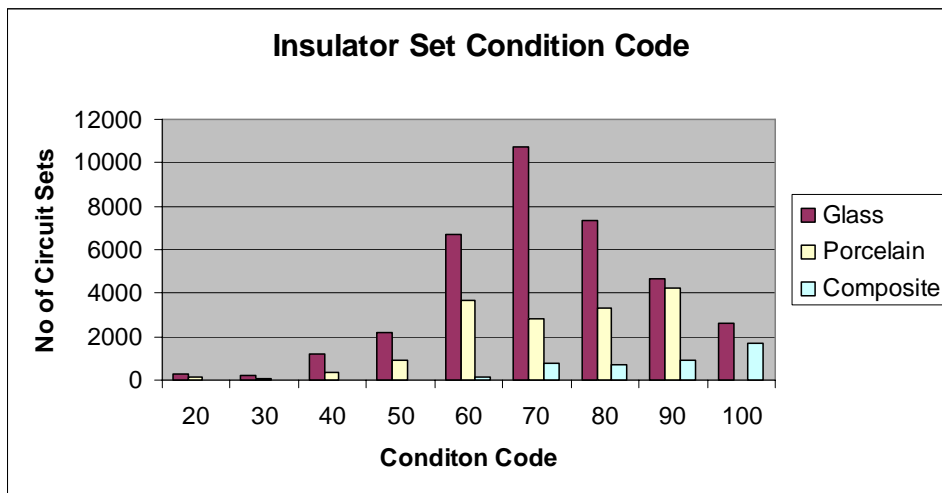
Figure 3-21: Insulator condition

Porcelain insulators manufactured before 1970 are considered suspect due to poor quality control during manufacturing, which may lead to in-service internal deterioration of the porcelain. Figure 3-21 shows the condition codes for the various insulator sets on the network. A circuit set will generally consist of three insulator strings on a suspension structure, and nine strings on a strain structure.
