QUALITY PERFORMANCE REPORT 07/08

Keeping the energy flowing

TRANSPower

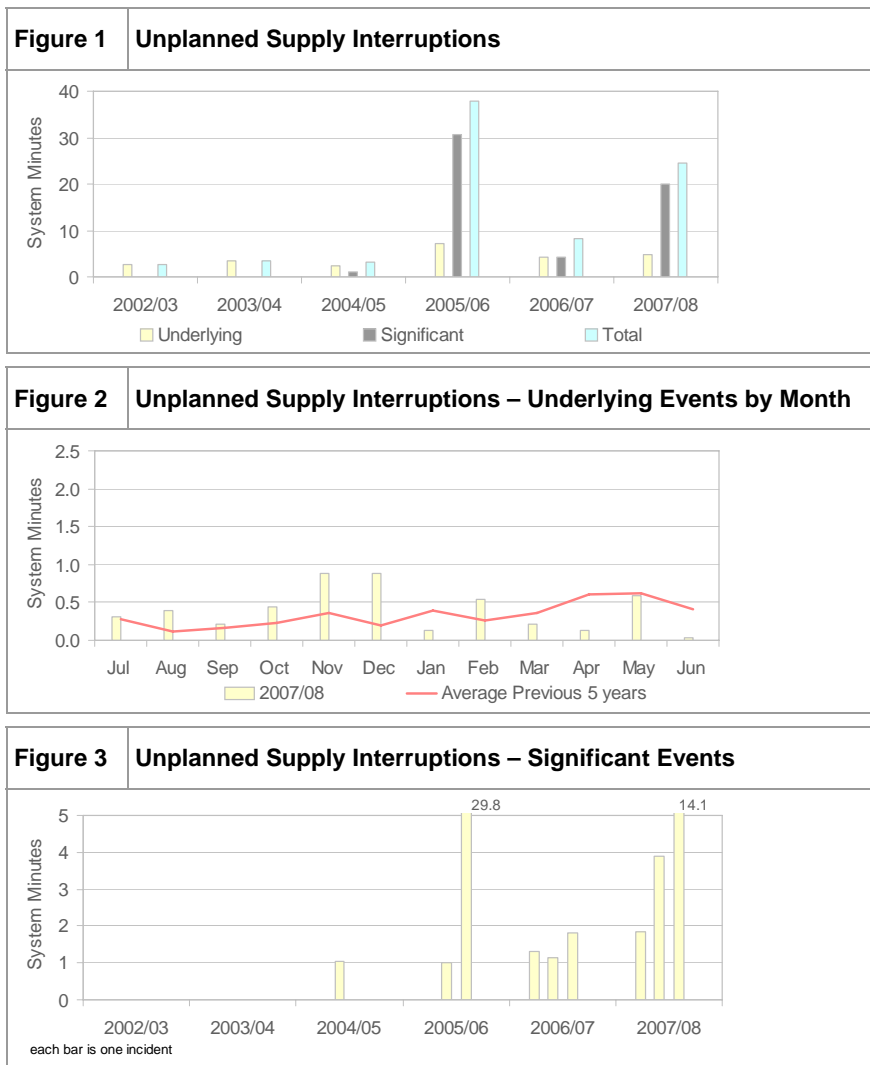
Figure 2 shows monthly performance in terms of underlying unplanned supply interruptions for the 2007/08 year compared to the average of the previous five years. This wide monthly variation is to be expected given the relatively random nature of interruption-to-supply incidents.

Figure 3 illustrates both the number and impact of significant unplanned non-supply incidents for 2007/08 and the preceding five years.

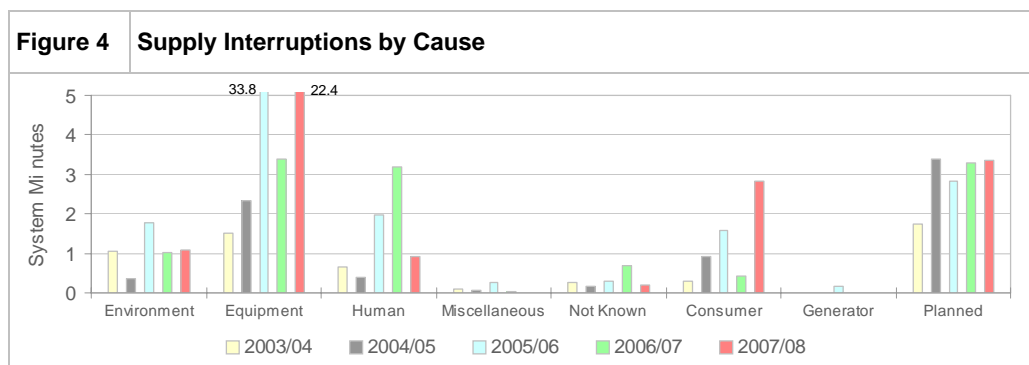
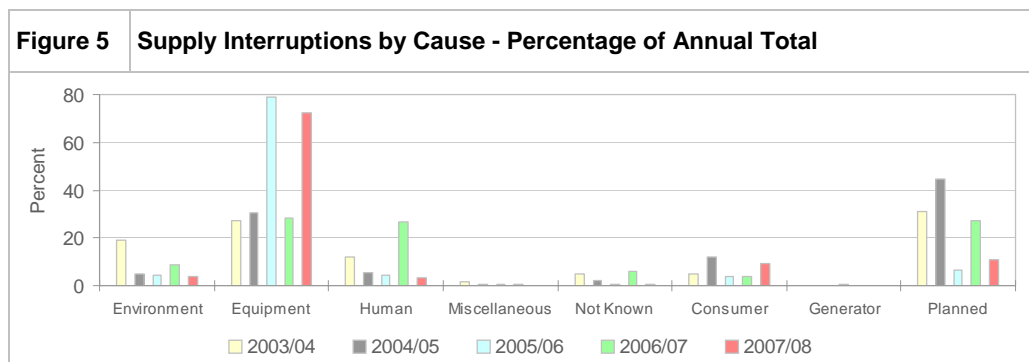
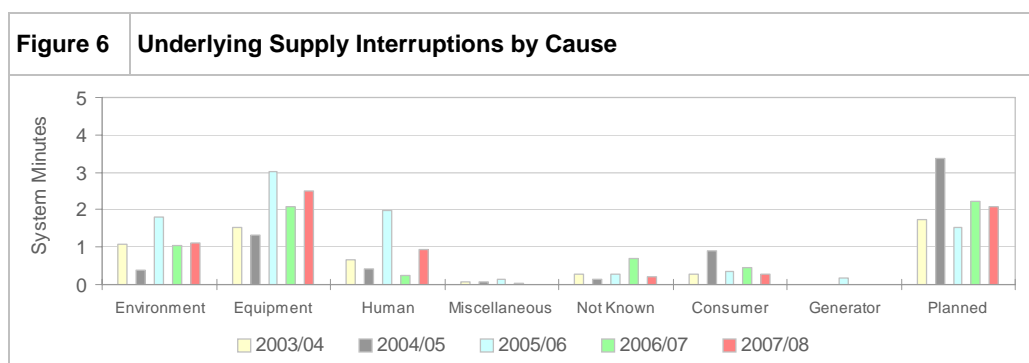
Figure 4 shows the system minutes of non-supply by cause for each of the last five years.

Figure 5 shows the same data as percentages of the total annual system minutes of non-supply in Figure 4.

Figure 6 shows the causes of underlying supply interruptions for the last five years. In this graph significant interruptions (greater than one system minute) have been excluded.

The data in Table 2 is presented graphically in Figure 4, Figure 5 and Figure 6.

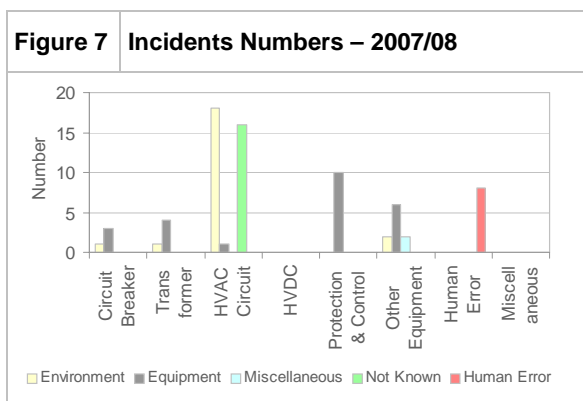
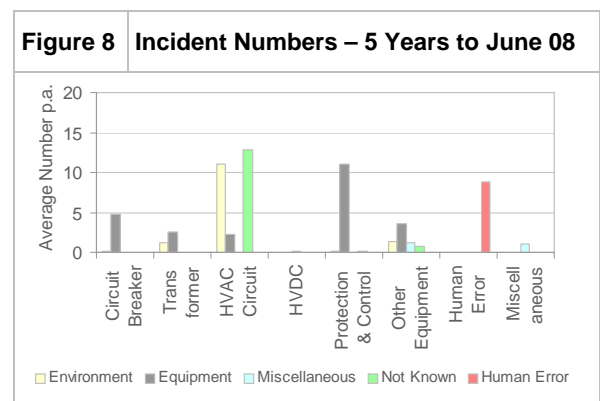
Figures 7 to 10 provide a further breakdown that takes into account the item of equipment that was responsible for the non-supply incident as well as the cause. Note that one incident may cause several interruptions; for example, a double circuit fault on the Inangahua – Kikiwa circuits caused interruptions at a seven different points of supply.

Figure 7 shows the numbers of incidents causing interruptions in 2007/08 and Figure 8 shows the five year average number of incidents. Similarly, Figure 9 and Figure 10 show a similar analysis for the system minutes of non-supply.

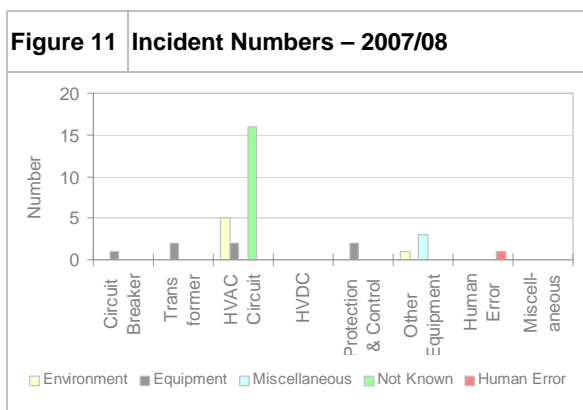
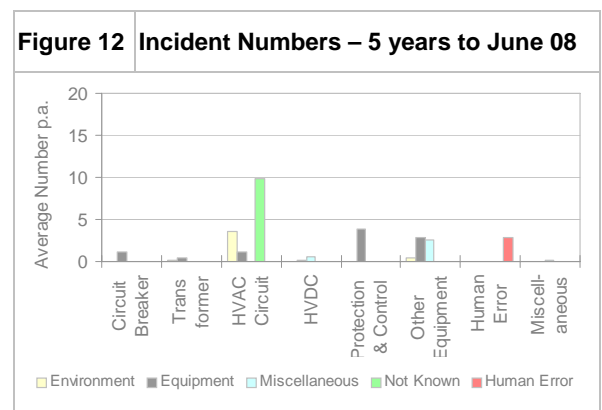
Figure 11 and Figure 12 show the numbers of incidents causing forced interruptions to connection for direct connected generators for the 2007/08 year, and the five-year average respectively. The figures show that incidents due to HVAC circuit trippings are above the average, while the numbers in the other categories are similar to or better than the five-year average. Most of the HVAC circuit incidents involved the Balclutha-Berwick-Halfway Bush circuit and the Blenheim-Argyle-Kikiwa circuit which suffered from a number of transient faults from unknown causes. In both these cases the generator is reliant on a single circuit connection to the grid.

Figures 11 to 14 provide a summary of the causes of unplanned interruptions to grid connection for direct connected generators. The categories used are the same as those for Figures 7 to 10.

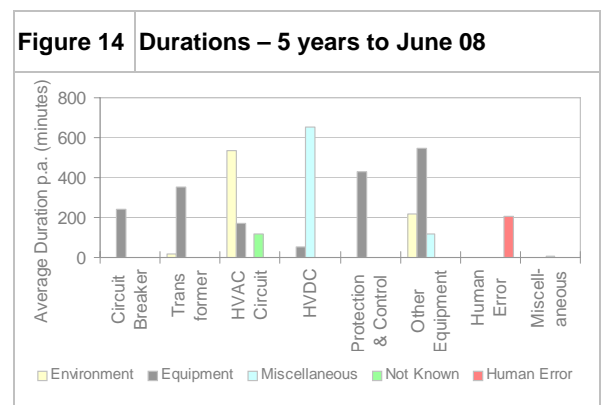
Figure 13 and Figure 14 show the total duration in minutes for forced interruptions to connection for direct connected generators. For 2007/08, the lengthy duration for transformers was caused by a cooling problem on a transformer at Benmore. A 220 kV bus fault which occurred at Maraetai during a thunderstorm caused interruptions to connection at Maraetai and Waipawa.
