2010/11

TRANSPower

This is Transpower New Zealand Limited's 20th annual Quality Performance Report. It sets out operational performance data that enables Transpower's stakeholders to make an assessment of the company's performance against measures incorporated in the company's 2010/11 Statement of Corporate Intent.

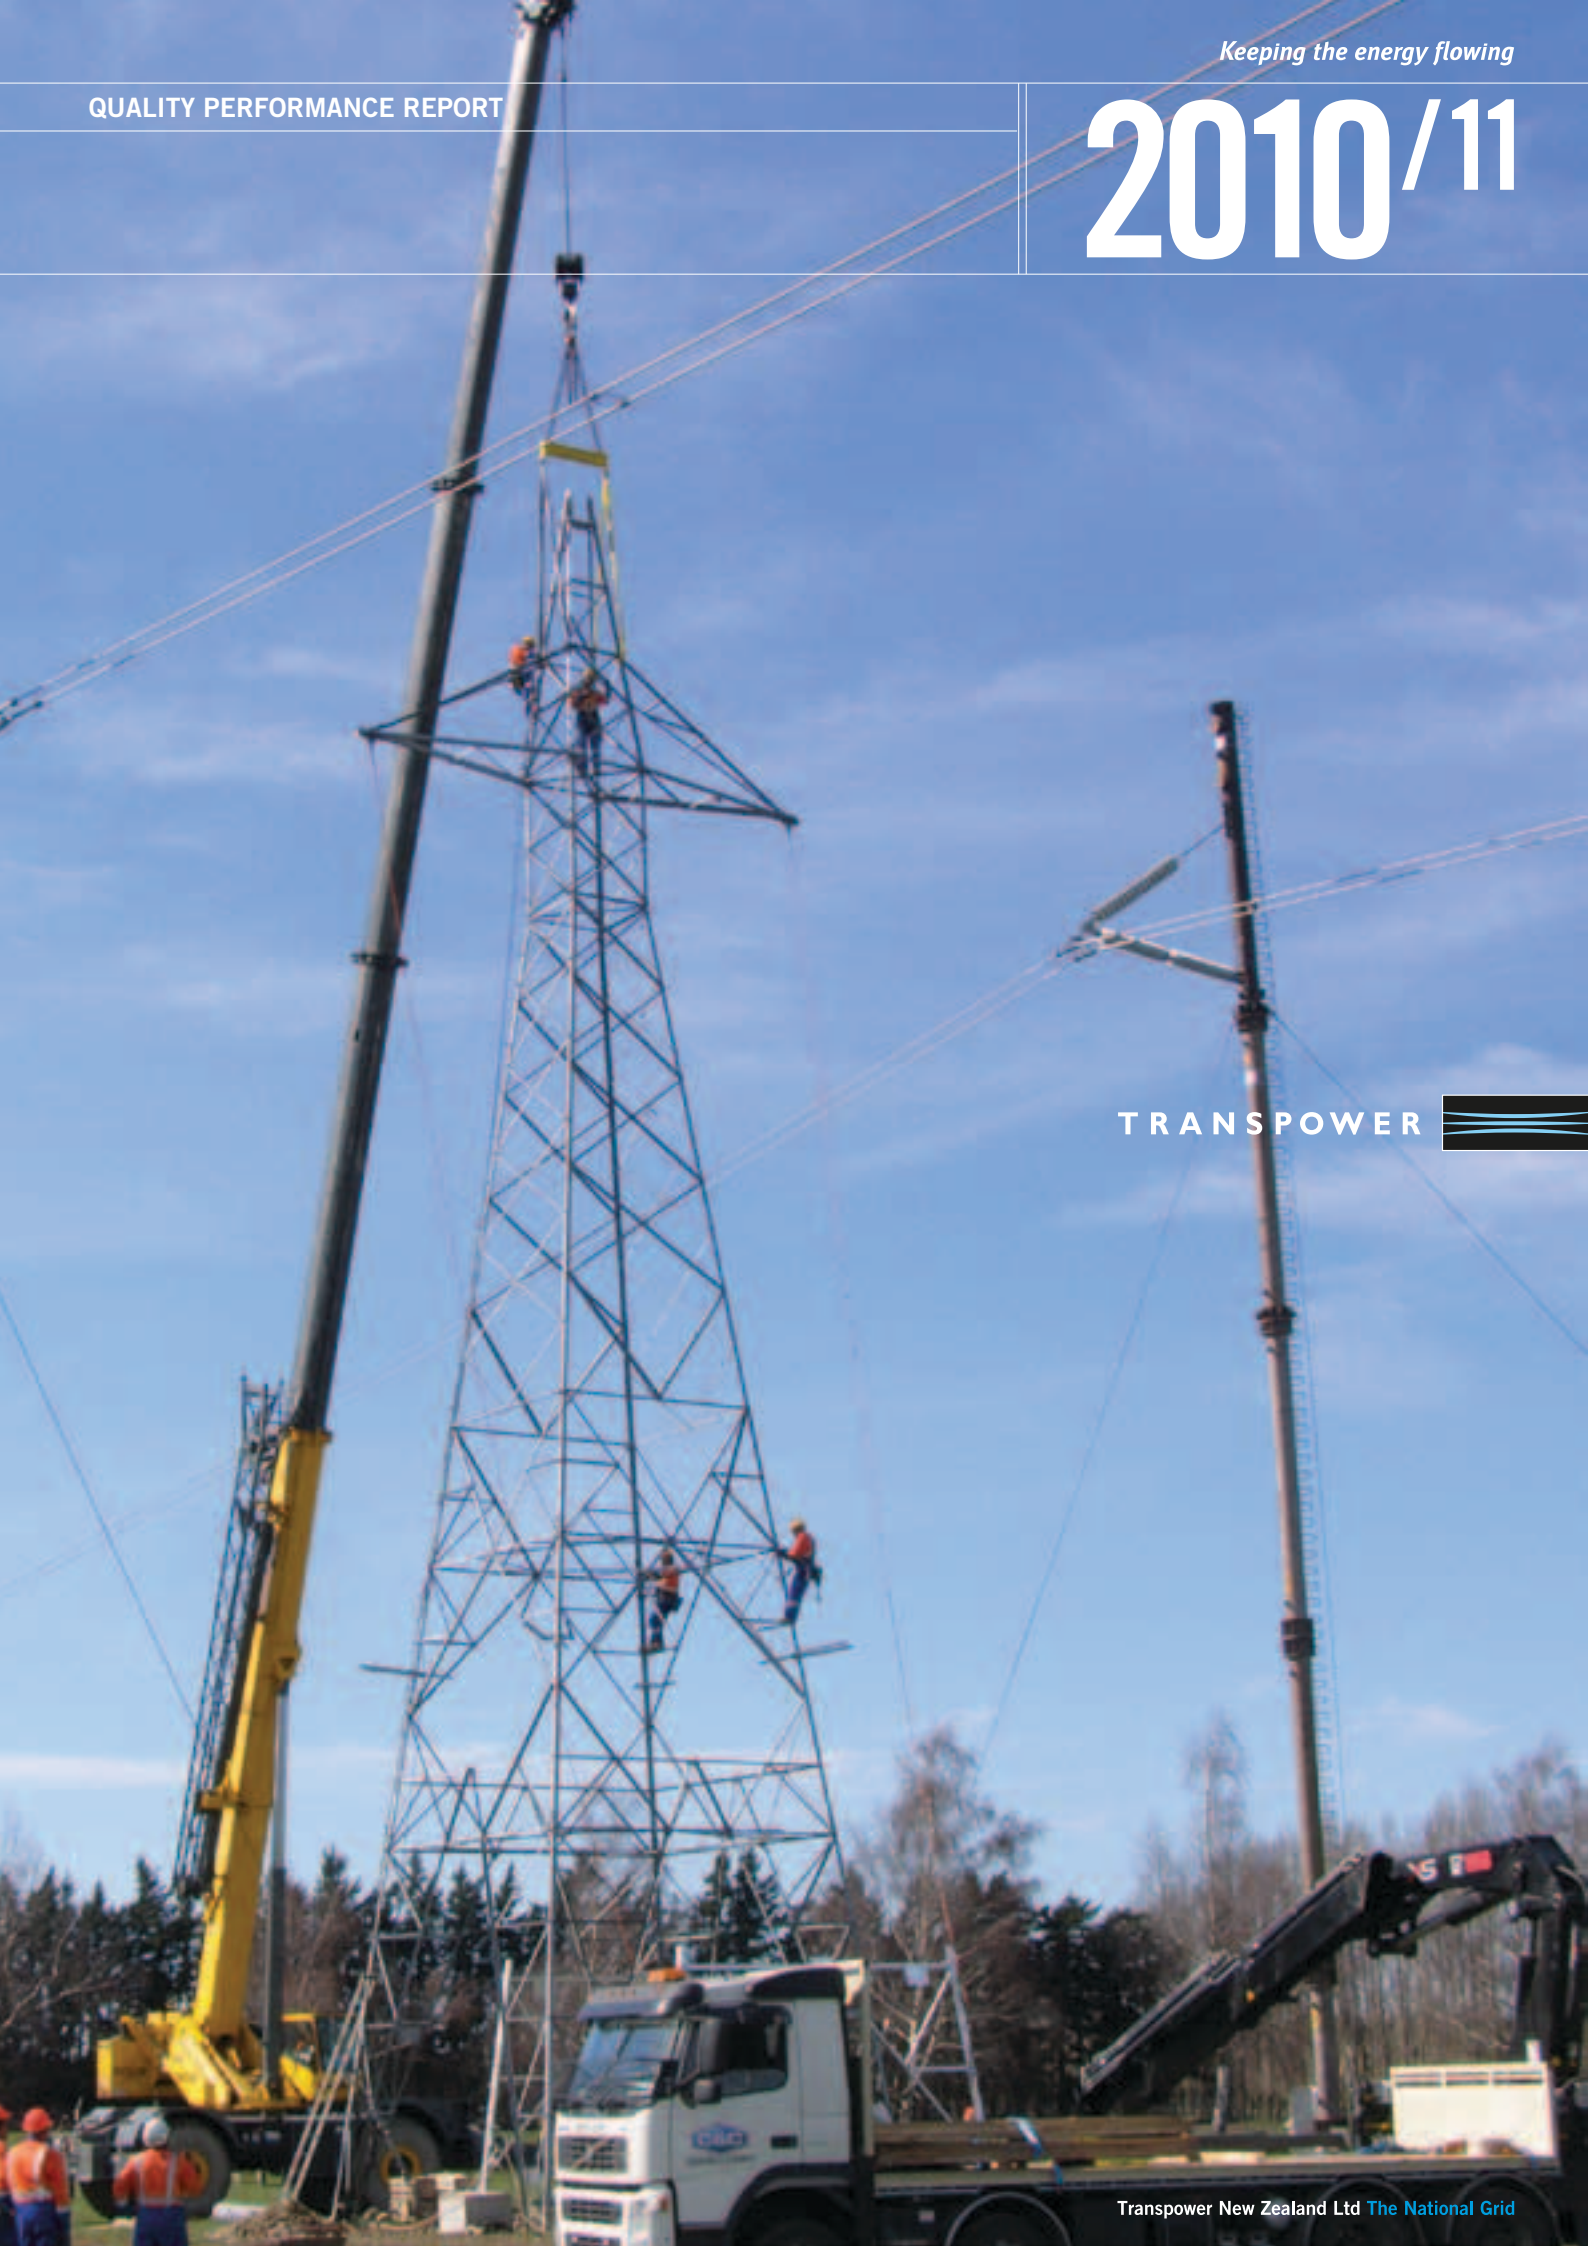
Cover image: HVDC line clearance removal project. The 350 kV transmission line has been removed from the existing tower and placed on a temporary pole using a crane. The crew are preparing to remove the tower using a crane and will then place the new tower on new concrete foundations. The two linemen in the centre of the tower are removing the bolts to enable that section of the tower to be lifted free. All the work carried out is live line.

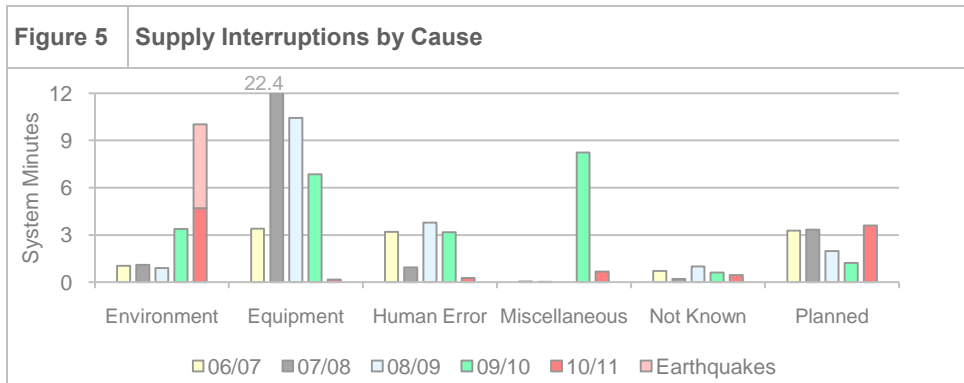
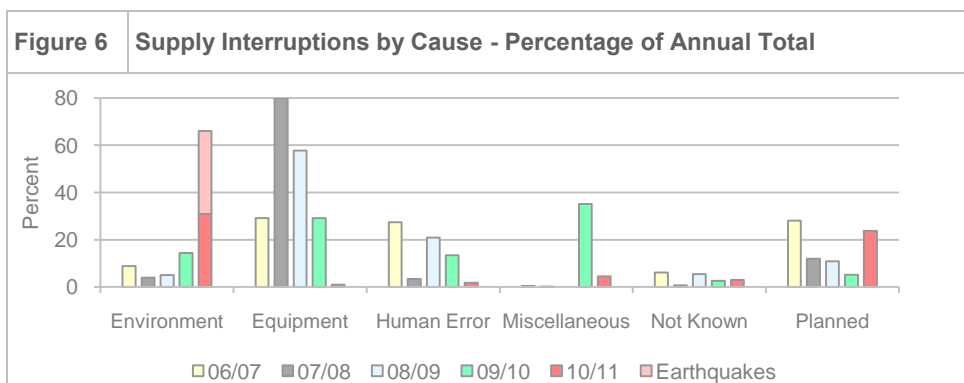
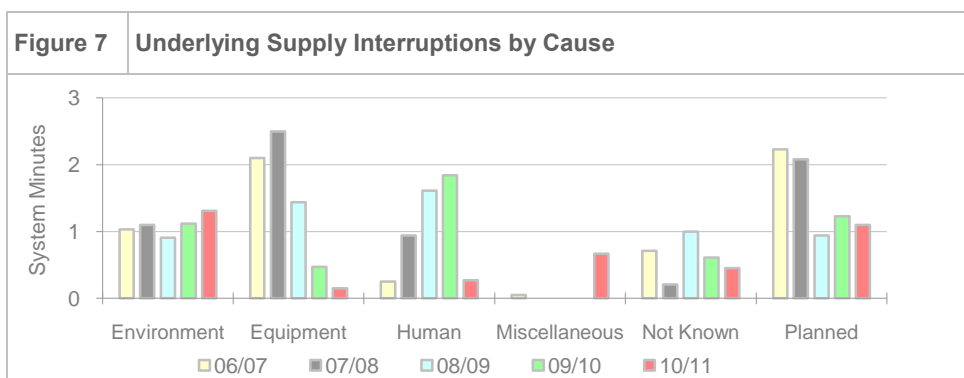
Figure 5 shows the system minutes of non-supply by cause for each of the last five years.

Figure 6 shows the same data as percentages of the total annual system minutes of non-supply in Figure 5.

Figure 7 shows the causes of underlying supply interruptions for the last five years. In this graph significant interruptions (greater than one system minute) have been excluded.

The data in Table 3 is presented graphically in Figure 5, Figure 6 and Figure 7.

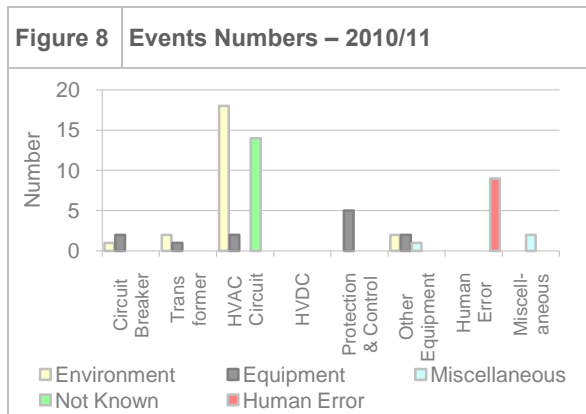
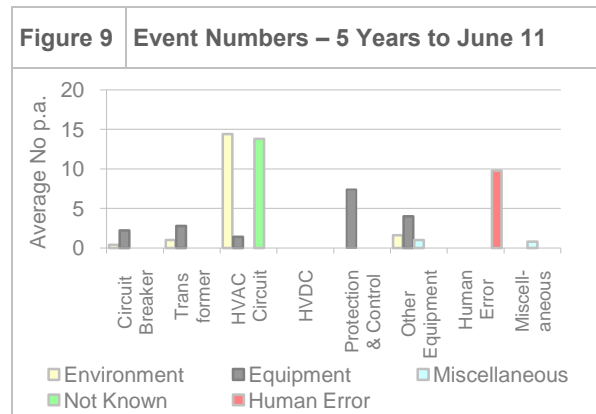
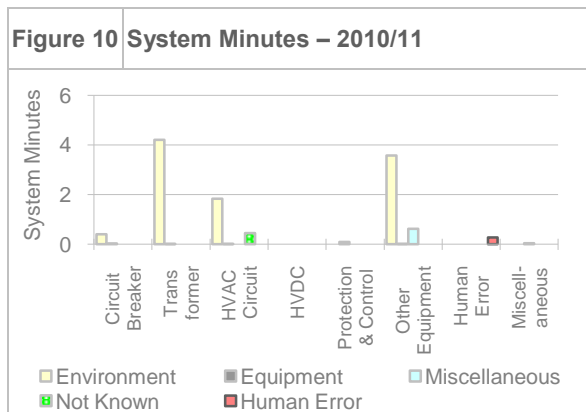
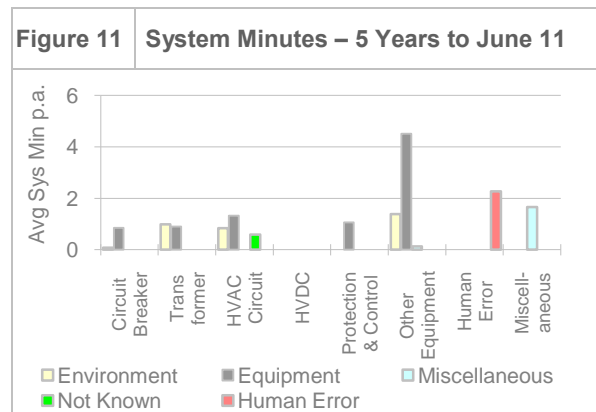
Figures 8 to 11 provide a further breakdown that takes into account the source (i.e. the item of equipment or initiating agent) of the non-supply event as well as the cause. Note that one event may involve several interruptions; for example, a circuit fault on the Coleridge-Otira circuits caused interruptions at five different points of supply.

Figure 8 shows the numbers of events causing interruptions in 2010/11 and Figure 9 shows the five-year average number of events. Figure 10 and Figure 11 show a similar analysis for the system minutes of non-supply.

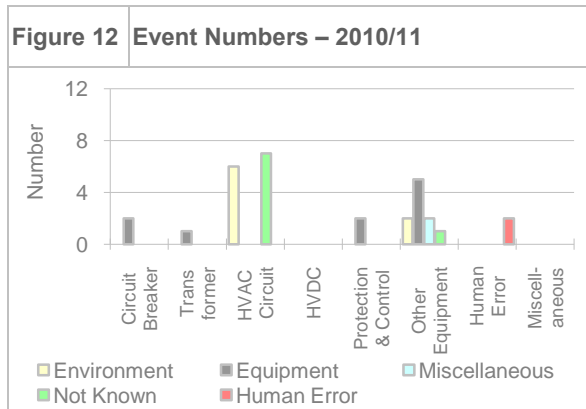
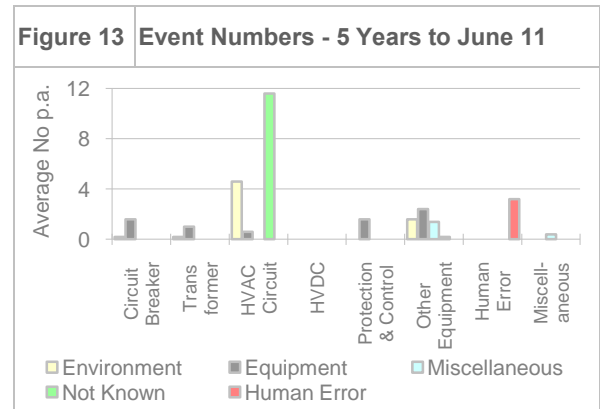
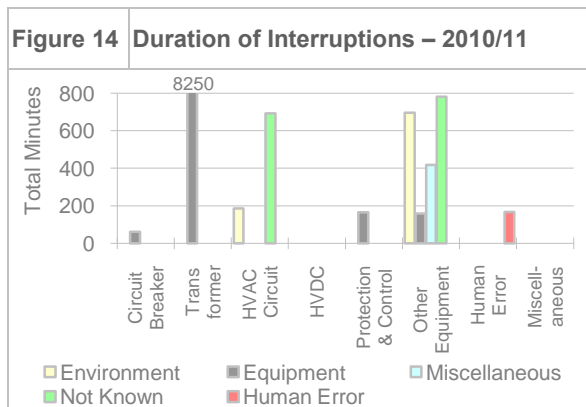
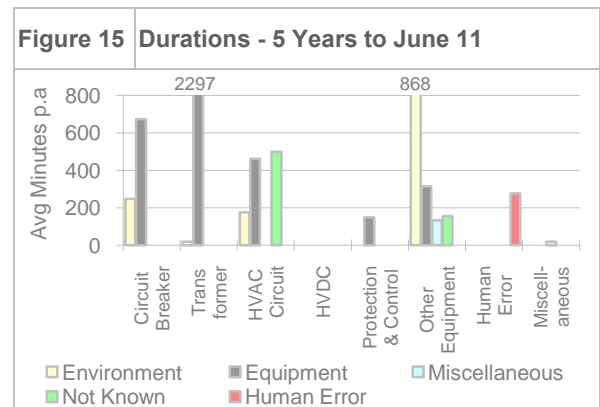
Figures 12 to 15 provide a summary of the unplanned interruptions to direct connected generators by equipment type and cause. The categories used are the same as those used for Figures 8 to 11.

Figure 14 and Figure 15 show the total duration in minutes for unplanned interruptions to connection for direct connected generators. The total duration for 2010/11 is substantially higher than the five-year average. However one outage of a 220/16 kV transformer at Benmore accounted for the long duration for transformers in 2010/11. Two separate bus faults at Maraetai caused by bird droppings resulted in a total of 696 minutes of interruptions at Maraetai and Waipapa, and a problem closing a circuit breaker at Huntly caused a generator interruption of 781 minutes; these are shown in the 'Other' equipment category.

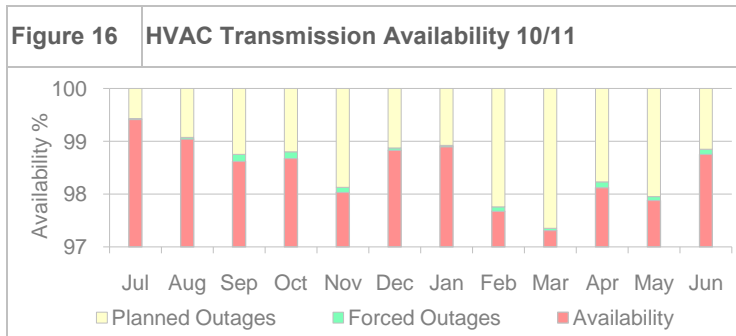
Figure 16 shows the monthly HVAC transmission circuit availability for 2010/11. The overall availability of HVAC circuits after allowing for forced⁴ and planned outages⁵ was 98.4 percent, and was below the target of 98.8 percent. This was primarily due to a number of line reconductoring projects that required outages lasting several months.

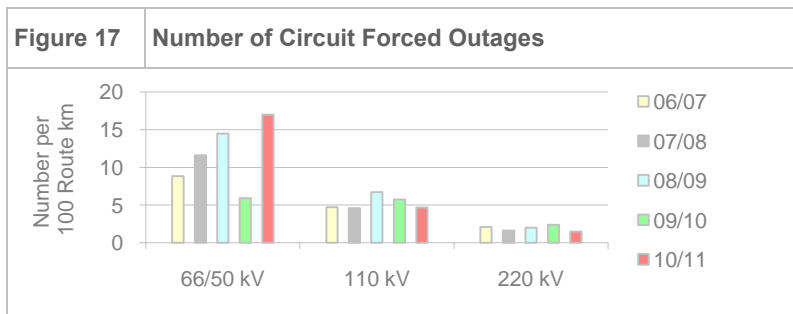
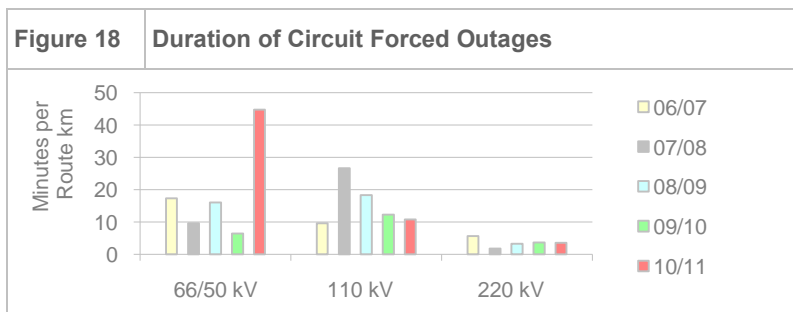
Figure 17 and Figure 18 summarise all circuit forced outages for any reason including faults on other equipment.

Figure 17 shows the total number of forced outages per 100 route-km by voltage. The number of circuit forced outages in 2010/11 was lower than in 2009/10 for the 220 kV and 110 kV groups, but there was a large increase in the number for the 66/50 kV group.

Figure 18 shows HVAC circuit performance measured by outage duration per route-km. Generally, performance has been improved, except for the 66/50 kV group which is dominated by the 70 forced outages of the Te Kaha Waiotahi circuit.

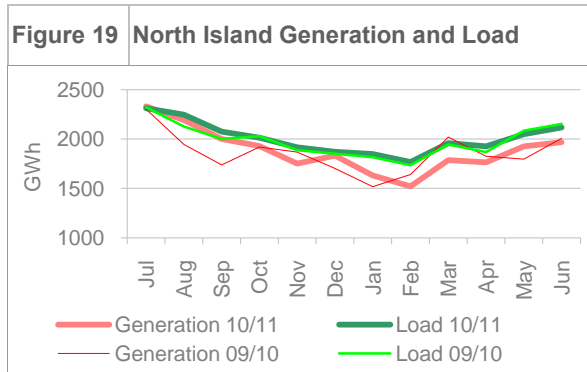
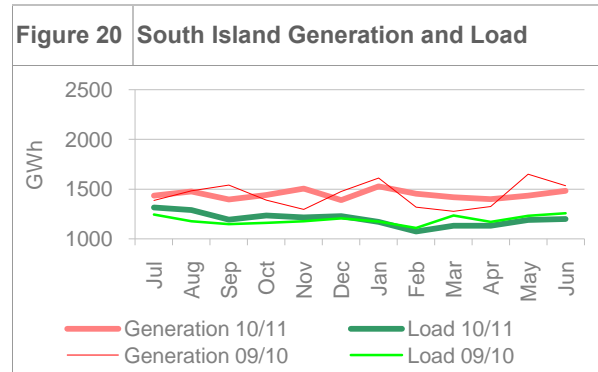
Figure 19 and Figure 20 show monthly North Island and South Island generation and load for 2010/11 and for comparison the previous year's generation and load. South Island generation onto the grid for 2010/11 was 65 GWh or 0.4 percent higher than for 2009/10. North Island generation onto the grid increased by 1.5 percent or 344 GWh.

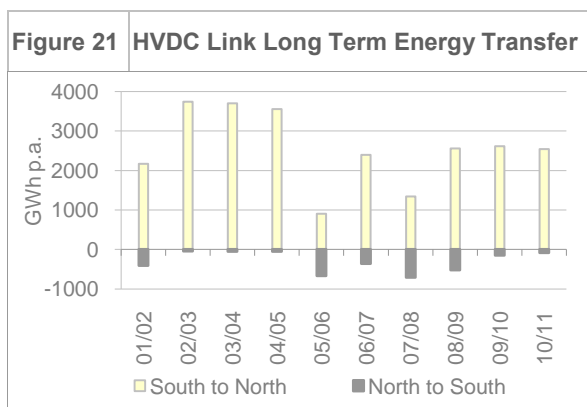
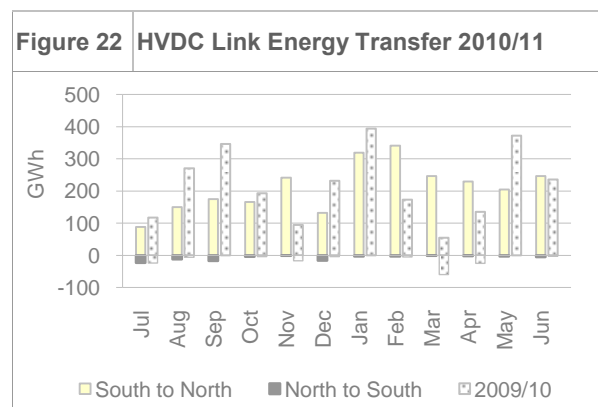
The net northward HVDC transfer reduced slightly in comparison to 2009/10. The northwards HVDC transfer for 2010/11 was 2540 GWh (sent from Benmore) compared to 2616 GWh in 2009/10 (Figure 21). The southwards energy transfer decreased from 150 GWh in 2009/10 to 91 GWh in 2010/11. The highest northwards transfers were in January 2011 and February 2011, and the highest southwards transfers were in July 2011 (Figure 22).

HVDC Pole 1 was stood down in September 2007 and was available only in a limited mode during 2010/11. The average utilisation of HVDC Pole 2 for 2010/11 was 42.9 percent, based on 700 MW capacity. Net northwards HVDC link transfers contributed 9.8 percent of the total energy supplied into the North Island grid for the year; almost the same as the 10.0 percent in 2009/10.

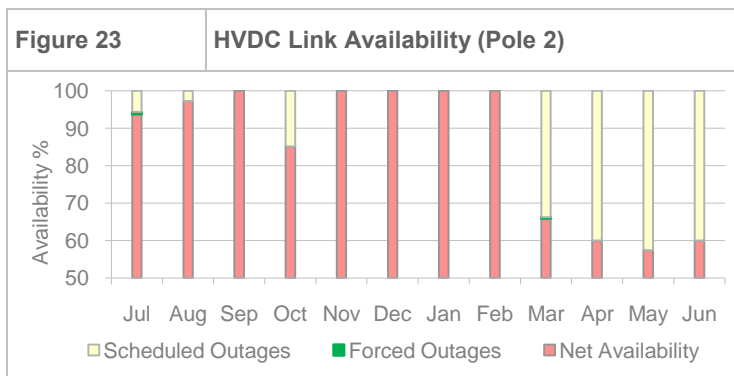
HVDC Pole 2 monthly availability is shown in Figure 23.

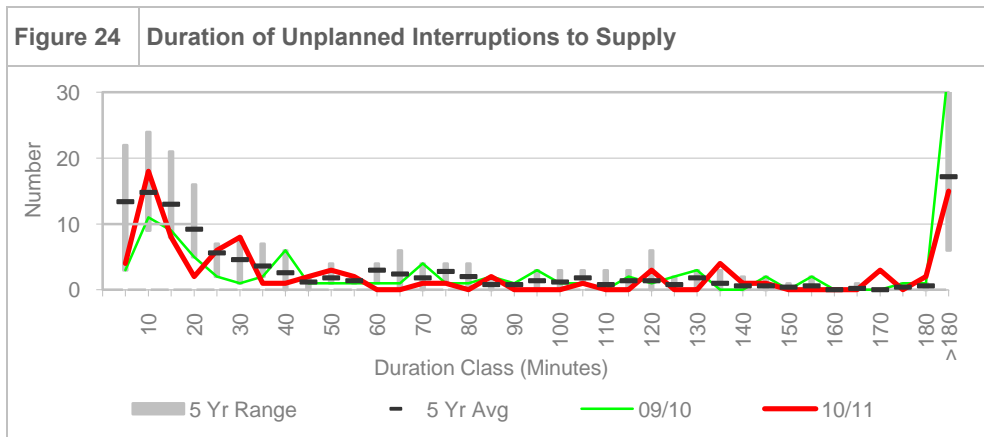
Eighty-nine unplanned supply interruptions originated on the Transpower system during 2010/11. This compares to 106 during 2009/10. Figure 24 shows the number and duration of these unplanned interruptions.

In Figure 24 the vertical bar indicates the spread of results, from the maximum value to the minimum value, over the period July 2006 to June 2011, with the average value indicated. The 2010/11 and 2009/10 results are shown as line graphs.

Interruptions with durations up to approximately 30 minutes are generally those that can be restored remotely, while those of longer durations are typically those that require an operator to attend or where investigations or remedial action is required before equipment is restored.

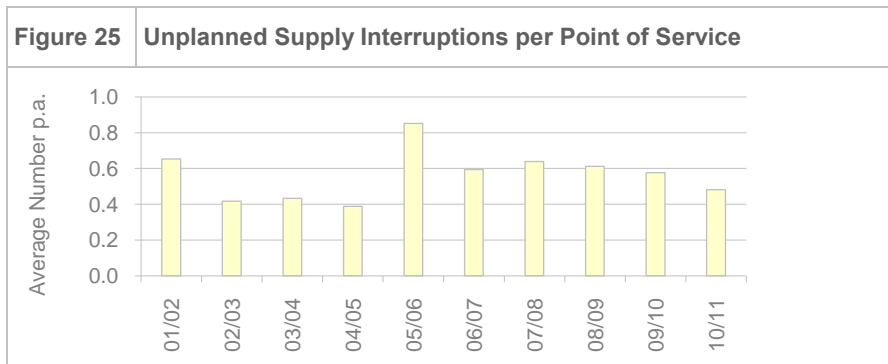
Figure 25 shows the average number of unplanned supply interruptions per point of service⁷ for the last ten years. In 2010/11 there was an average of 0.48 interruptions per point of service. This compares favourably with the performance over the previous five years, which peaked at 0.85 in 2005/06.

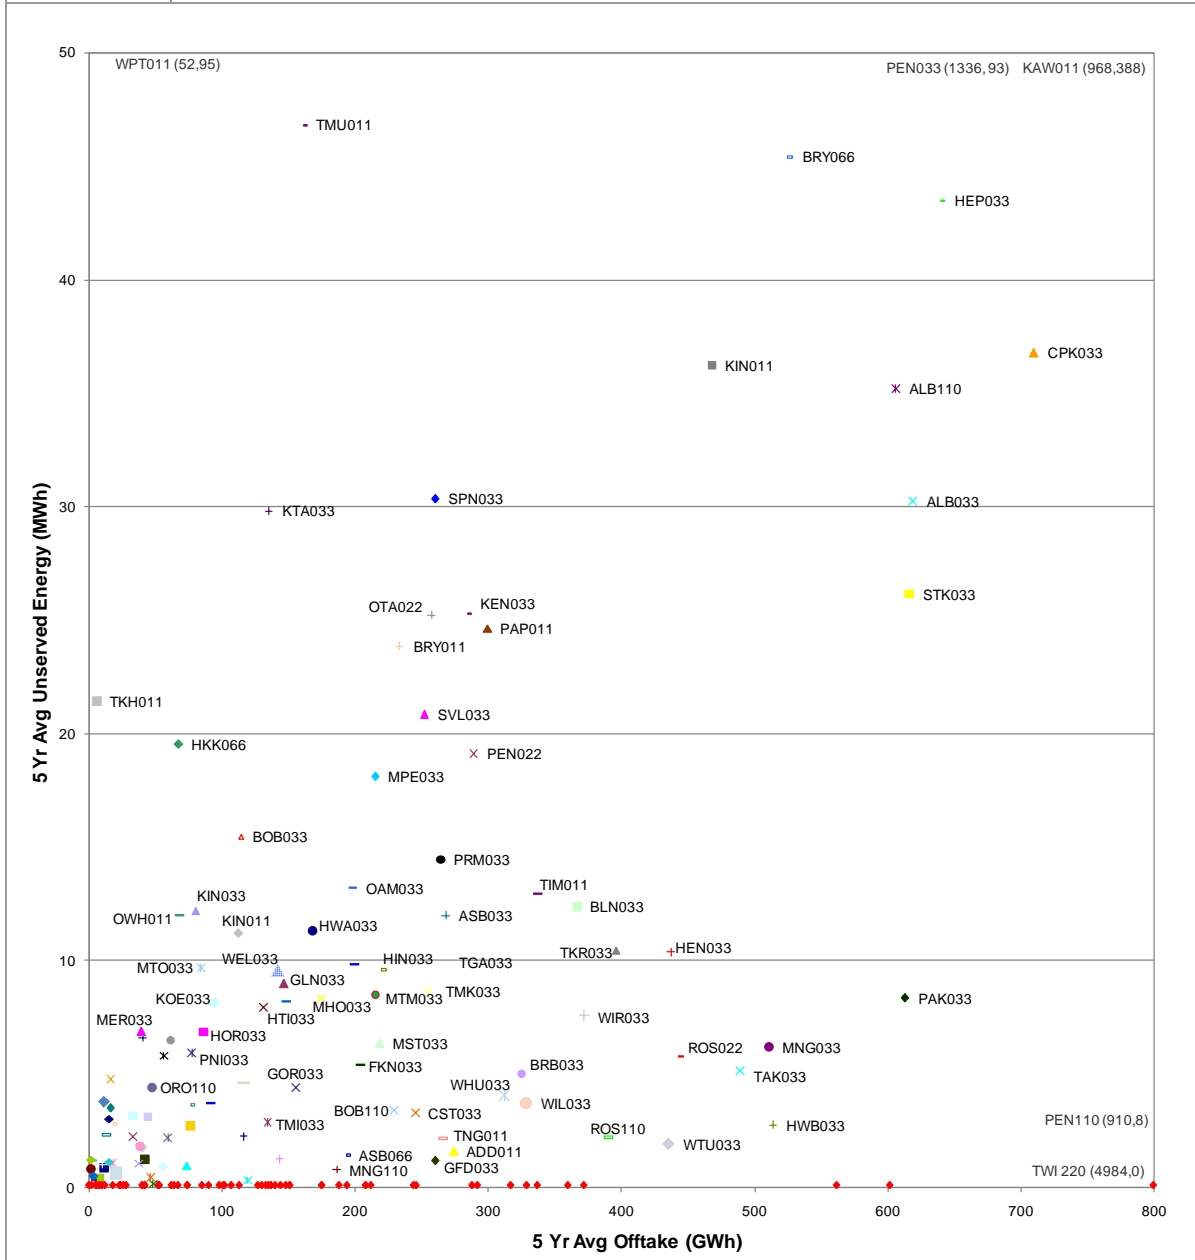
Unplanned Interruptions - Five Year Average Unserved Energy vs. Offtake GWh

Figure 26 on page 23 shows five year average annual unserved energy resulting from unplanned interruptions for each point of service as a function of the five year average annual off-take at the point of service.

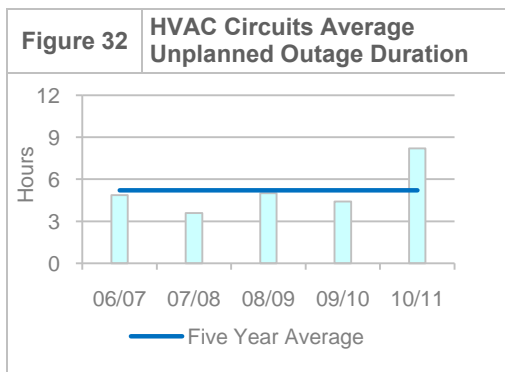
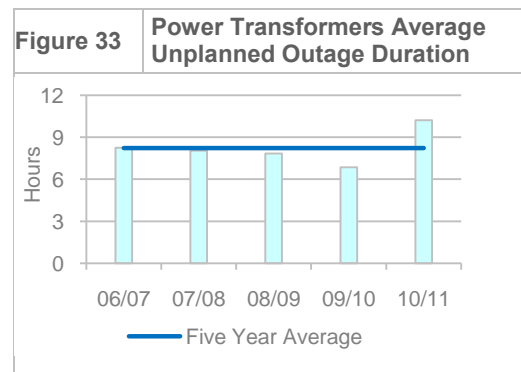
In addition to the performance measures defined in the Individual Price-Quality Path Determination, Transpower has also undertaken to track and report on two other possible measures, viz:- average unplanned outage duration for circuits and transformers. Historical performance for these measures is shown in Figure 31 and Figure 32. For this calculation, outages with long outages are capped at seven days.

Although there were a smaller number of unplanned circuit outages in 2010/11, the average duration is relatively high because of reduced numbers of short outages with a duration of less than one hour.

There were a relatively high number of long transformer outages during 2010/11, and the average outage duration was further increased by two long outages at Bromley as the result of earthquakes on 22 February and 6 March.
